RE: Site Inspection, State Stone/Keith McKay, Unpermitted Site,
M/055/021, Wayne County, Utah

Date of Inspection: January 30, 2004
Time of Inspection: About 2:50 to 3:30 p.m.
Conditions: Mostly cloudy, 40's, patchy snow up to about two inches deep
Participants: Paul Baker, DOGM

M/055/021, Unpermitted Quarry, State Stone

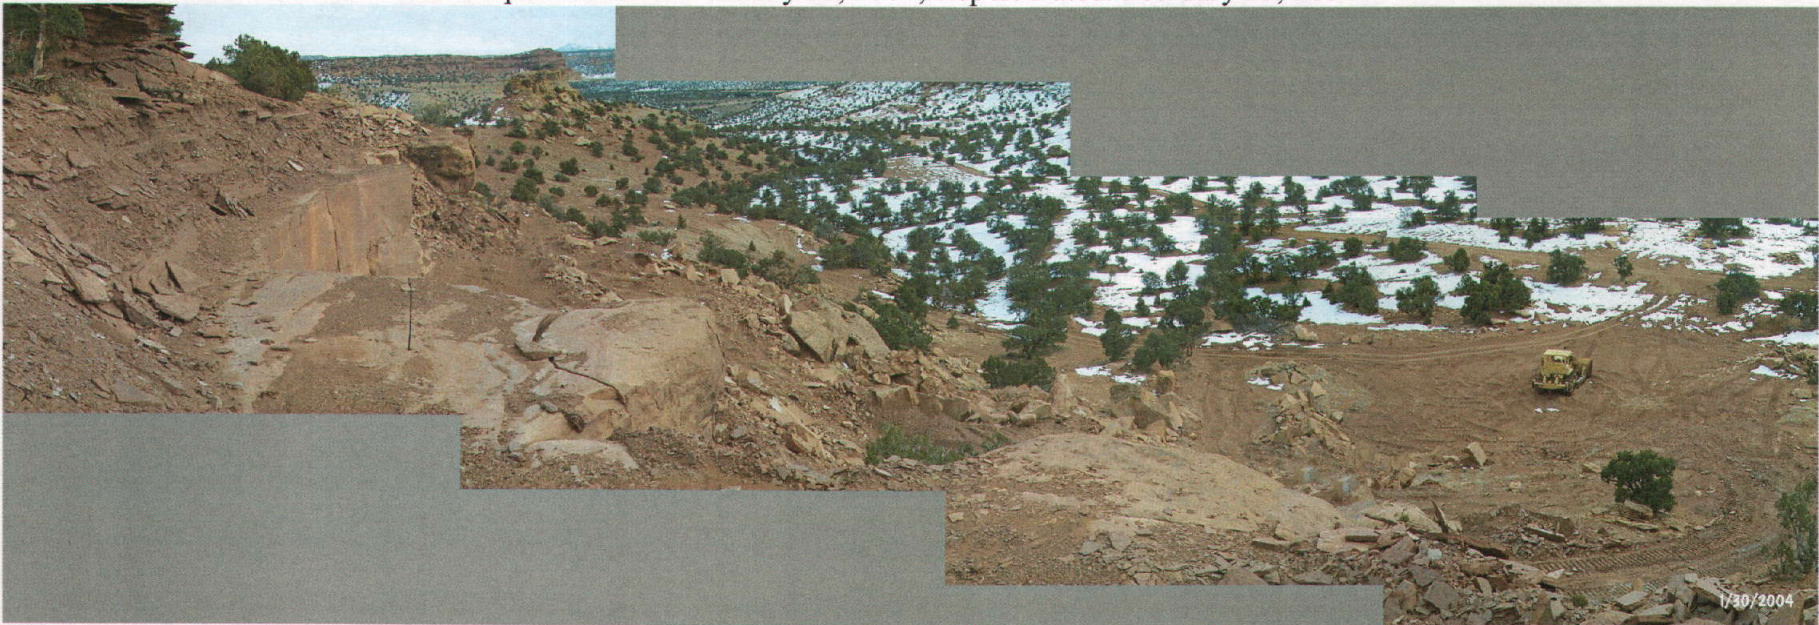
This site is a quarry from which sandstone blocks are being taken. It appears that most of the stone has been taken from the surface, but there have also been some blocks broken from the bedrock. Photo 1 is a composite of four photos taken in a panorama from above the outcrop.

Photo 1. Panorama of a portion of the site.

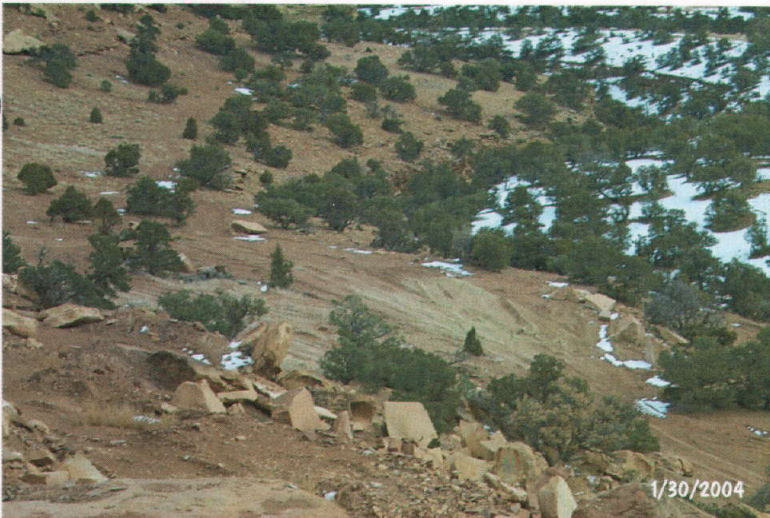
While most of the disturbance is at the base of the outcrop, there is a road leading to the top of the outcrop, and there is some disturbance in this area (Photo 2). This road continues approximately east from the area of the quarry, and it is possible it leads to other areas where there could be additional disturbance. I do not know this or have any indication it is true, but the next time I am in the area, I would like to see where the road leads.

Photo 2. More of the disturbance.

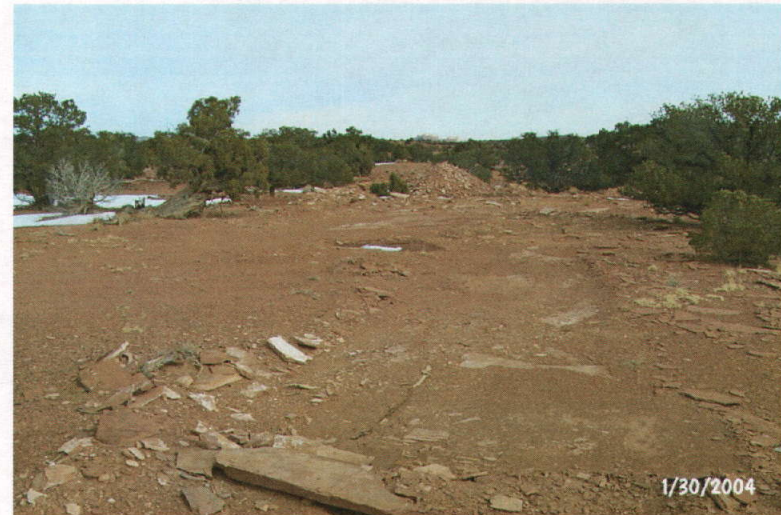
I found no indication that soil has been salvaged. Although soil is/was probably thin or non-existent over rock outcrops, working areas at the base of the outcrop, such as the area shown in Photo 3, do have soil that could have been salvaged.

Photo 3. Disturbance above the rock outcrop.

The operator needs to salvage and protect topsoil from the disturbed areas at the base of the outcrop. There appears to be limited soil on the outcrop itself, but, as far as reasonably possible, this soil should also be saved.

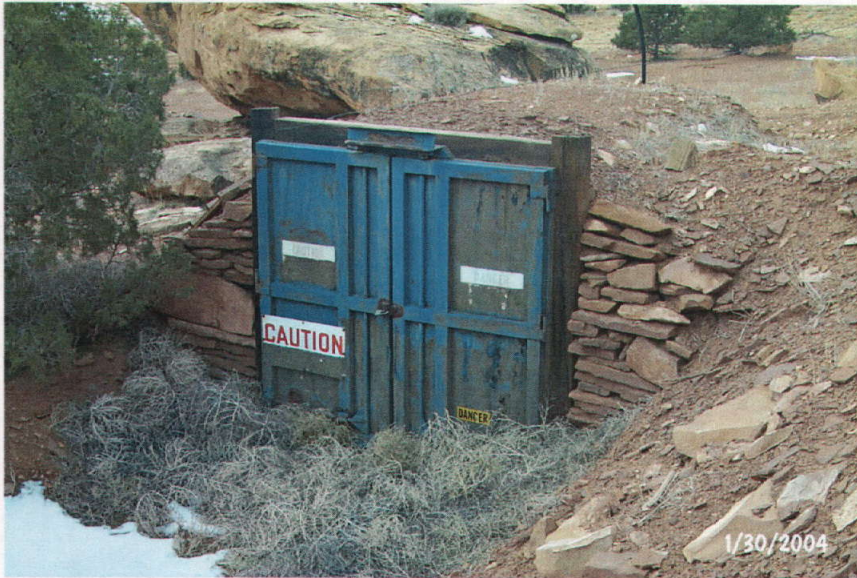
A powder magazine is somewhat hidden in a depression near the road leading to the top of the outcrop (Photo 4). It was locked, and I do not know whether it actually contains explosives.

Photo 4. The powder magazine.
